Brief Overview of the Head-On Collision Between Metrolink Train 111 and a Union Pacific Freight Train September 12, 2008

September 12, 2008 at 4:23 PM
Head-On Collision Between
Metrolink Train 111 and Union Pacific Freight Train

Richard W. Clark, Director
Consumer Protection and Safety Division
California Public Utilities Commission

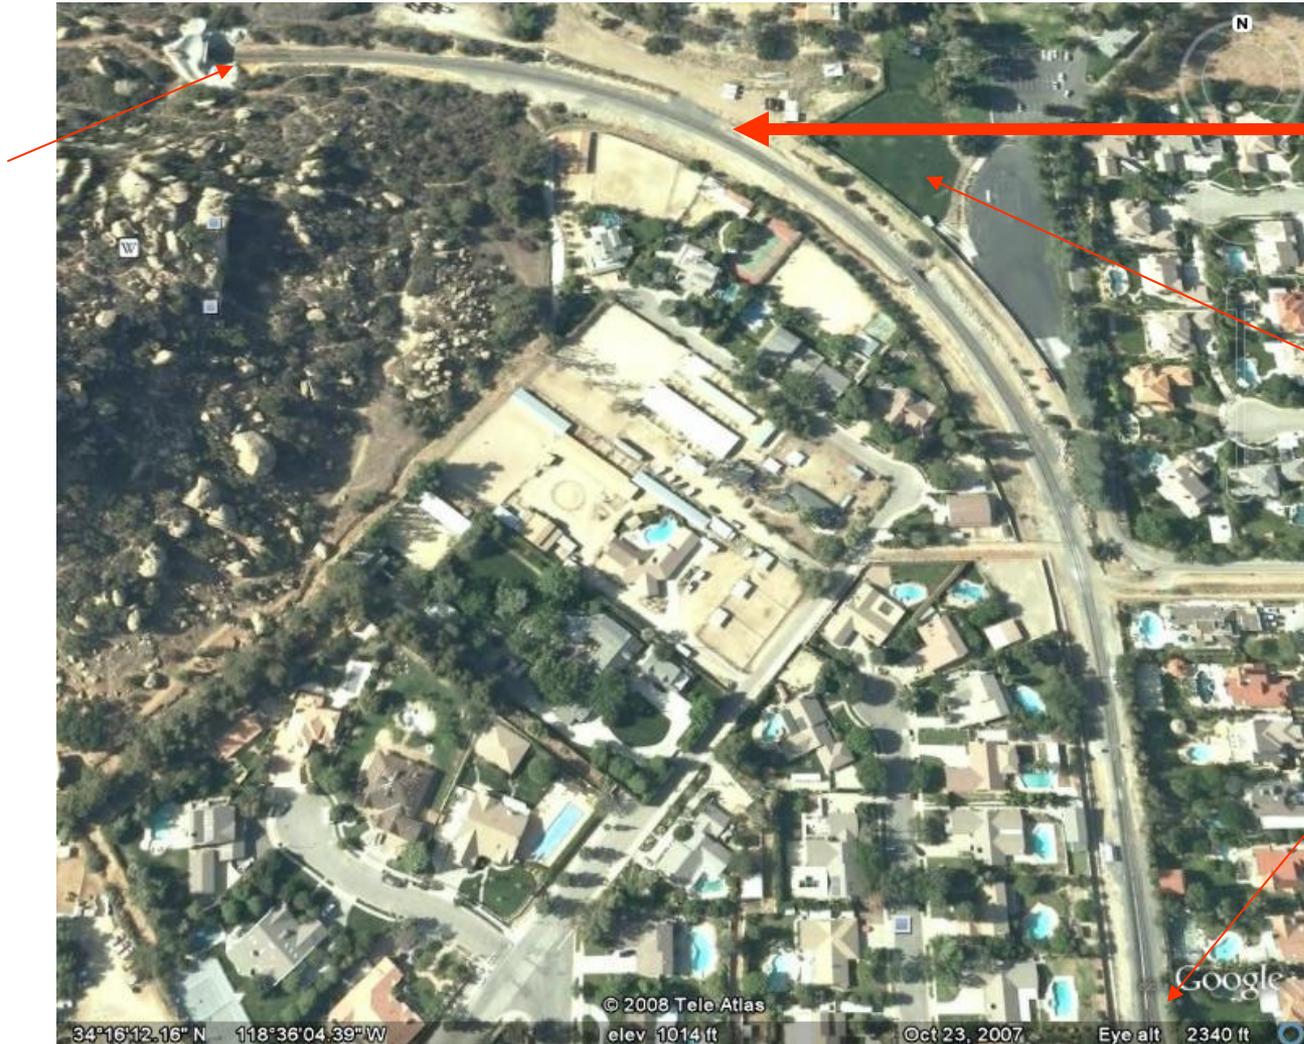
Overview – Looking North towards the tunnel

Tunnel where the UP Train Exited

Point of Impact

Approximate Location of Red Signal that the Metrolink Train "Ran Through"

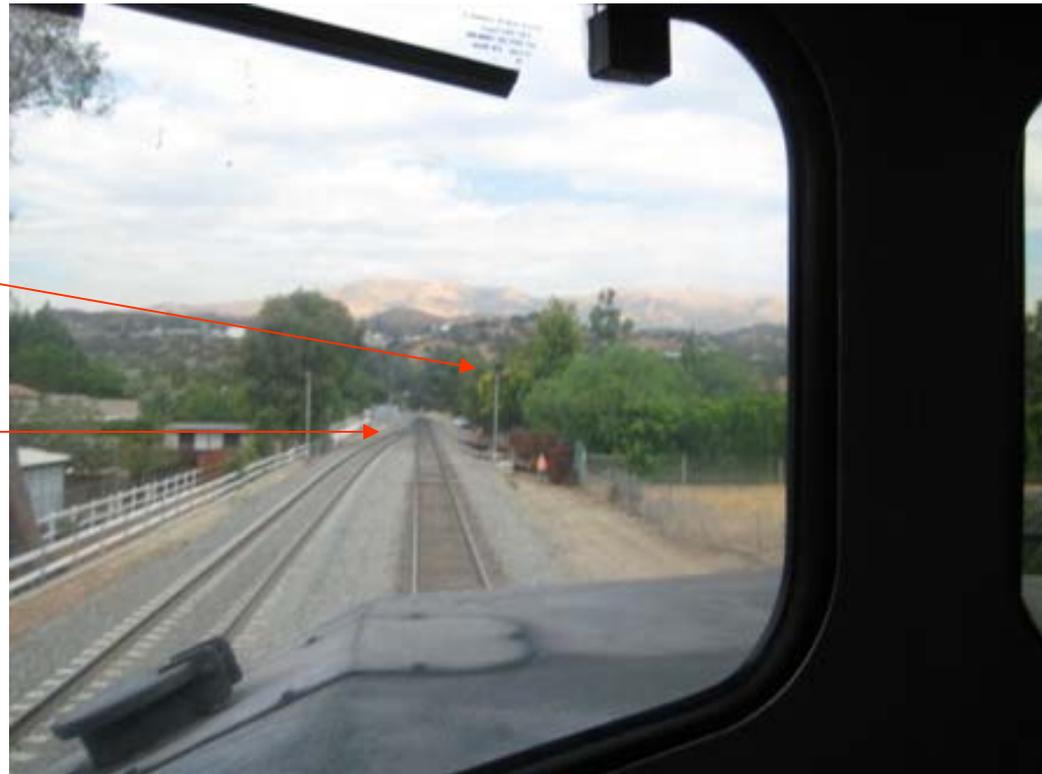
View from the Metrolink Locomotive approaching the Switch at CP Topanga – in the Distance is the left hand curve.

Signal Mast
(unobstructed
view), and
switch.

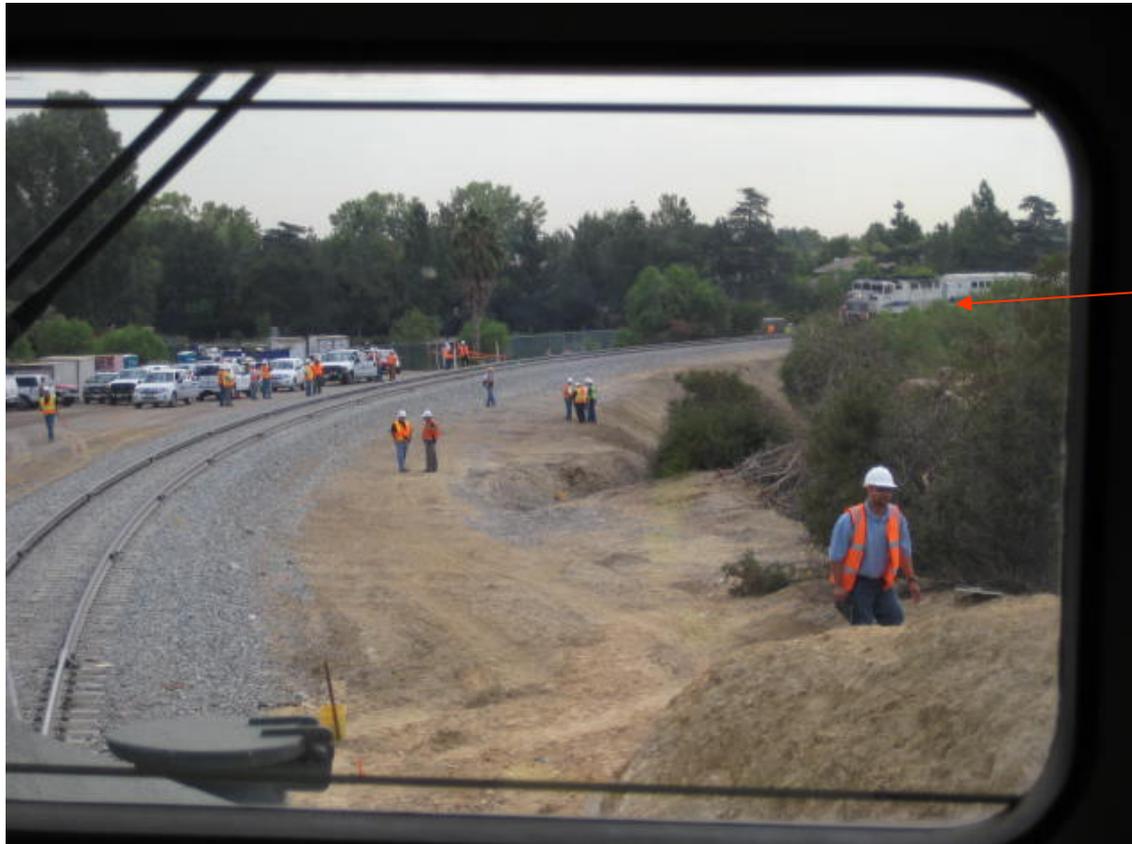
View that the UP Locomotive and Conductor had – 4 seconds from the Crash – Trains closing at over 80 MPH combined speed

Metrolink coming into the curve

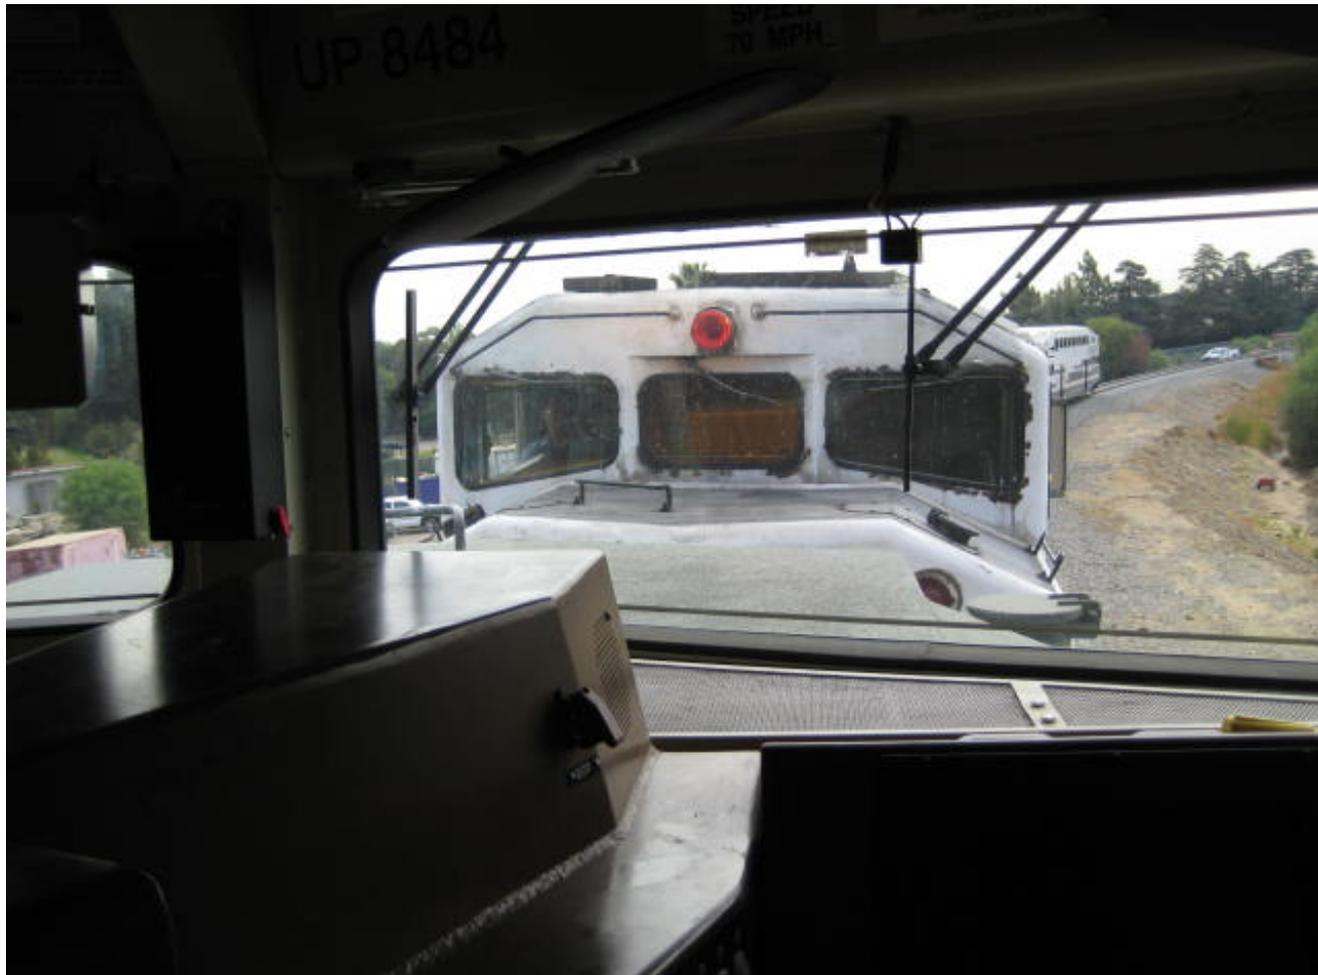
Impact – Closing Speed Approximately 80+ MPH

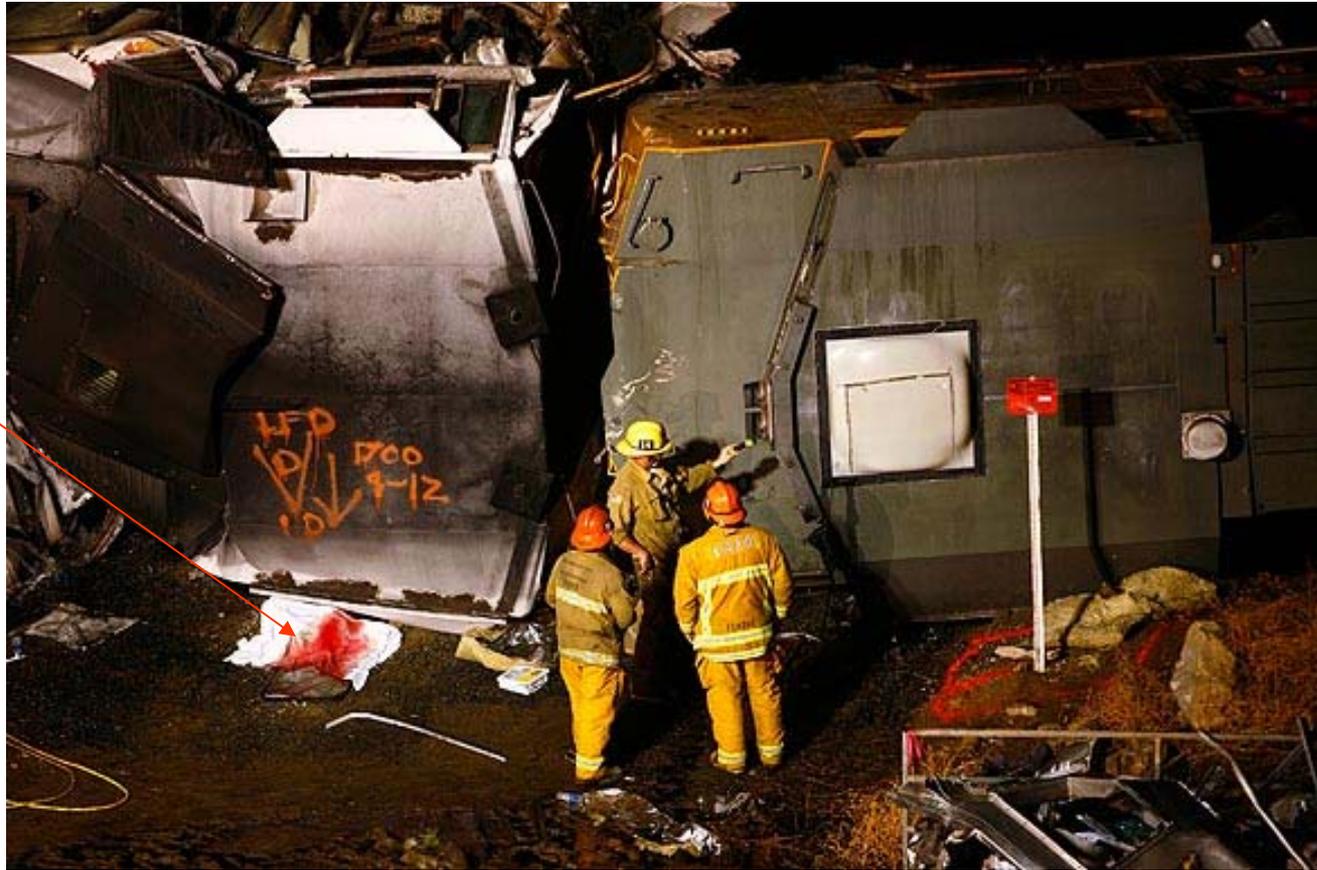
View of the Two Locomotive After Impact; On the Left is the Metrolink Locomotive (and Deceased Engineer); Right is the Union Pacific Locomotive.

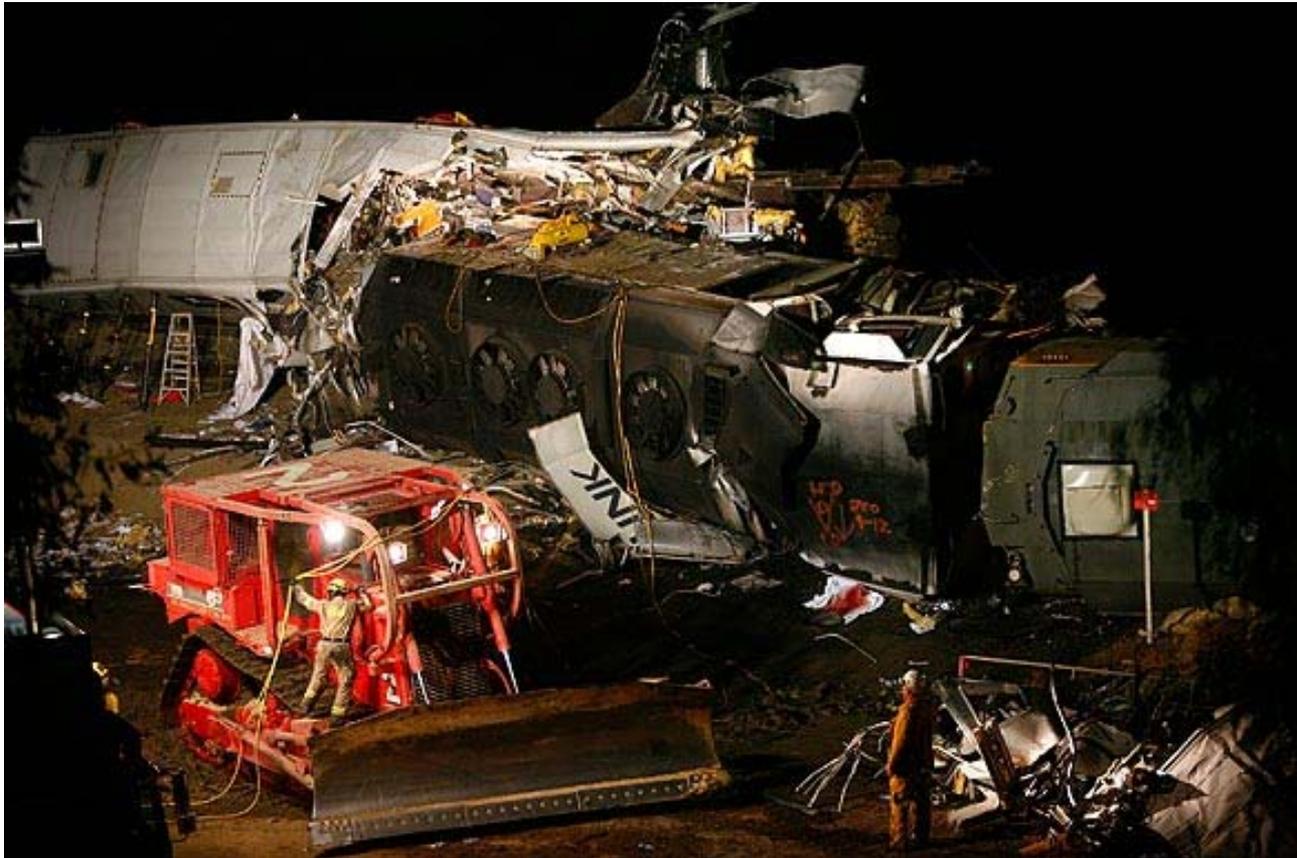
View of the Metrolink Locomotive Inside the Passenger Car.

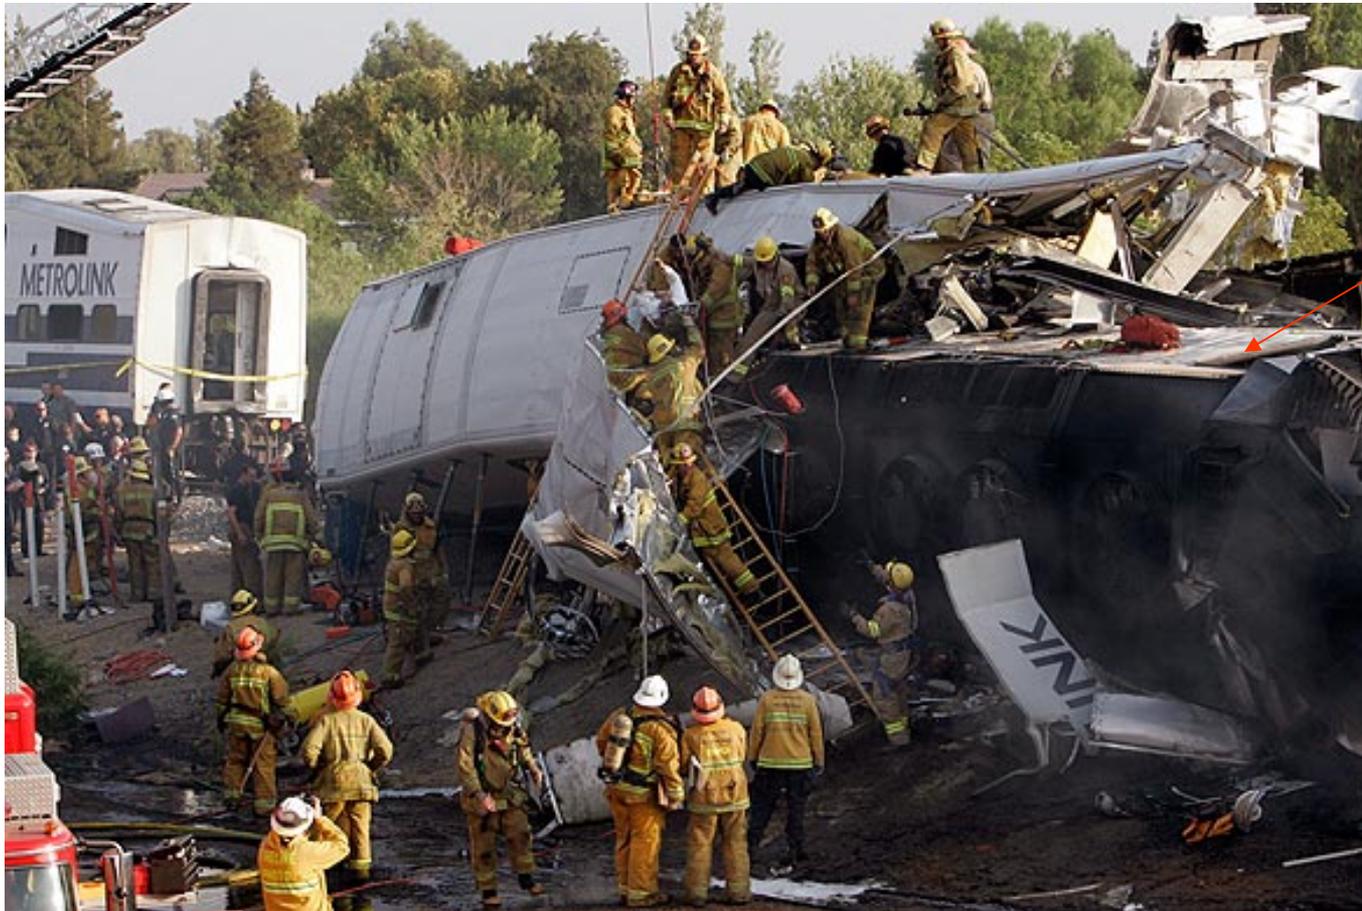
Full View of the Metrolink Locomotive after it “Telescoped” Into More Than 70% Of the First Passenger Car.

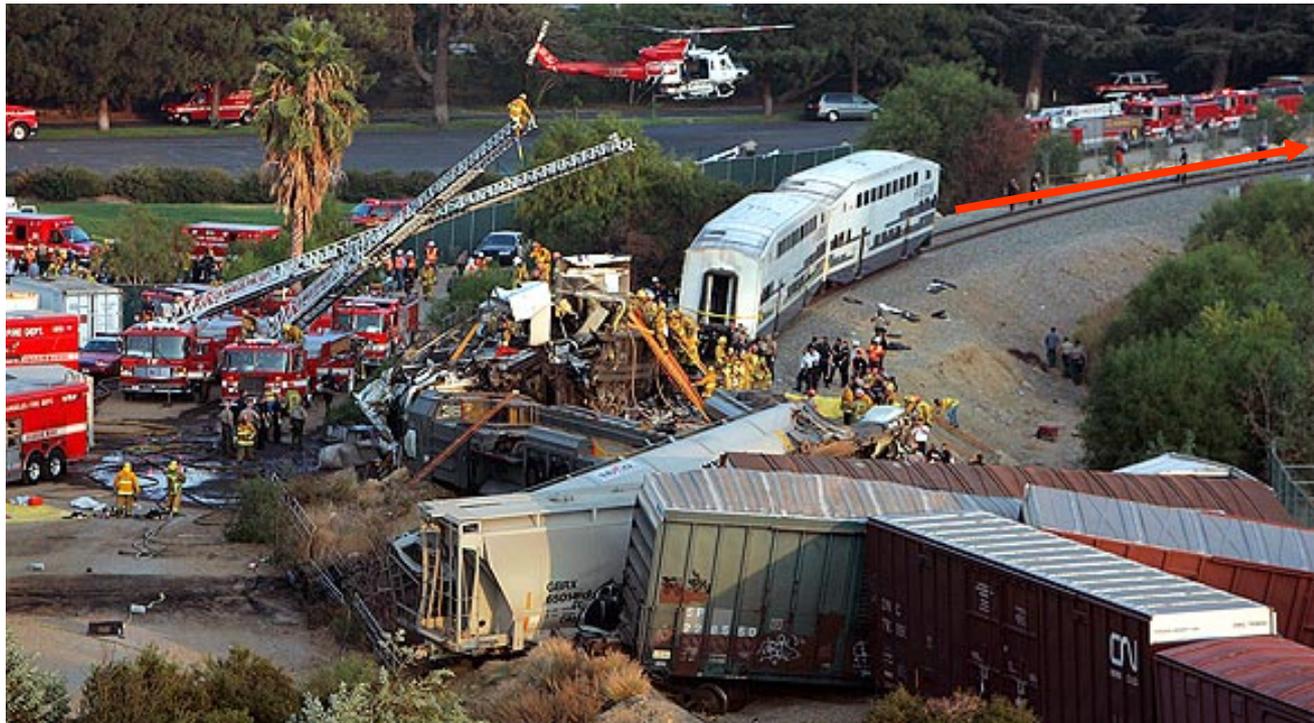
View Looking South; Two UP Locomotives on Their Sides with Seven Freight Cars Derailed “Accordion Style” Behind Them.

Approximately
1,462' to the
signal at CP
Topanga

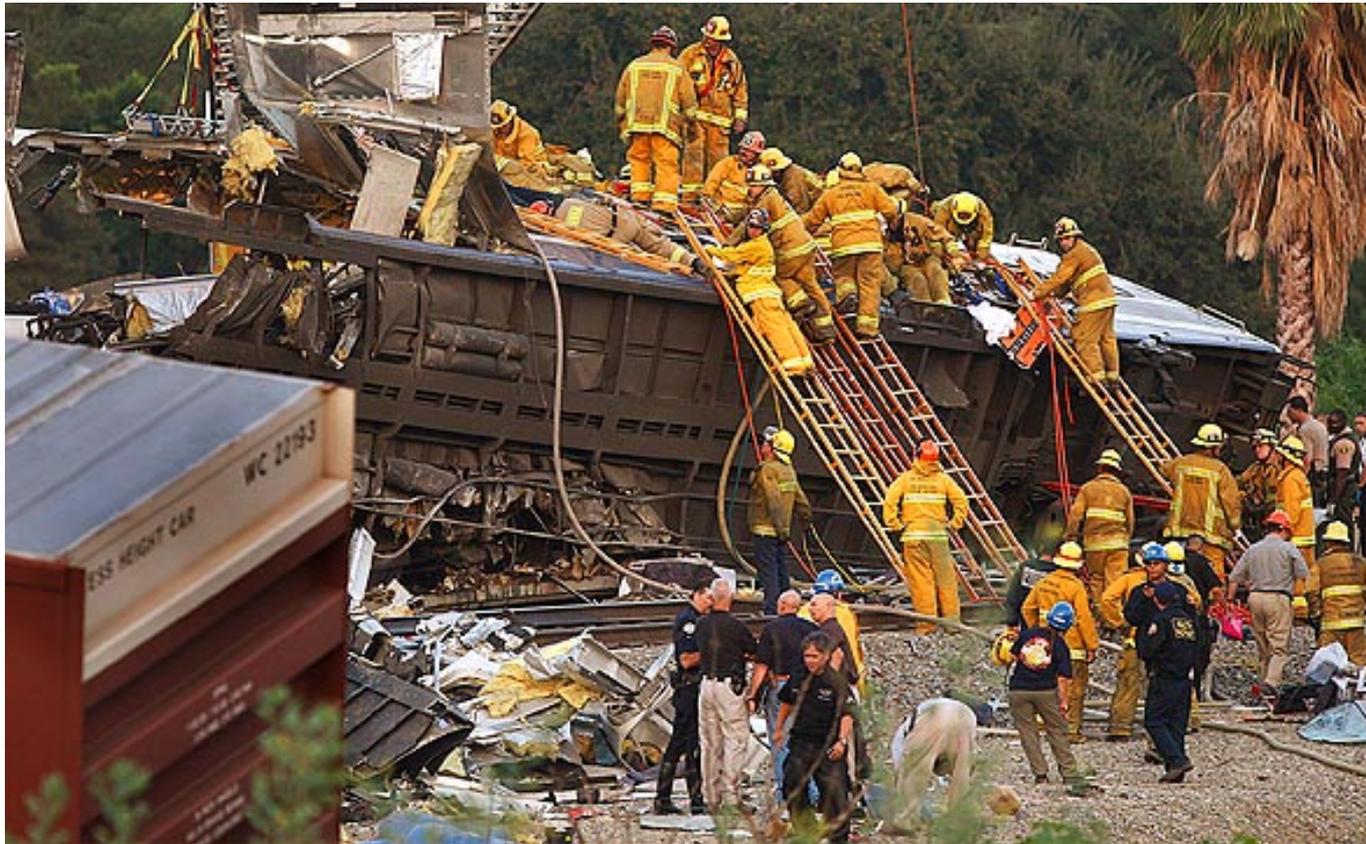
View From the West Side of the Rescue Operations; Note That the Emergency Responders are Leaning the Ladders on the “Bottom” of the Locomotive that was Jammed Into the First Passenger Car.

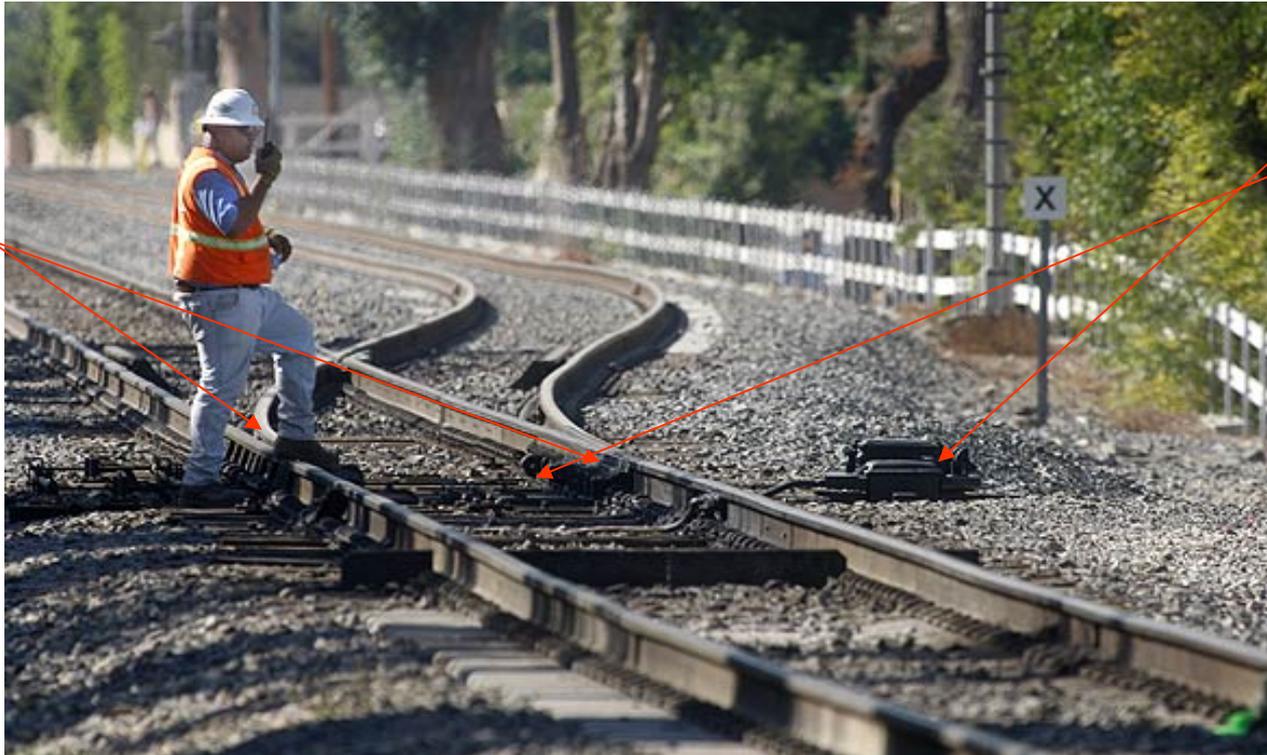
CP Topanga: View looking south of the Switch providing entry onto the siding track where the Union Pacific train would have met the Metrolink Train.

Note: the two Switch points

Switch Box and bars that were destroyed When the train "ran through" The Switch

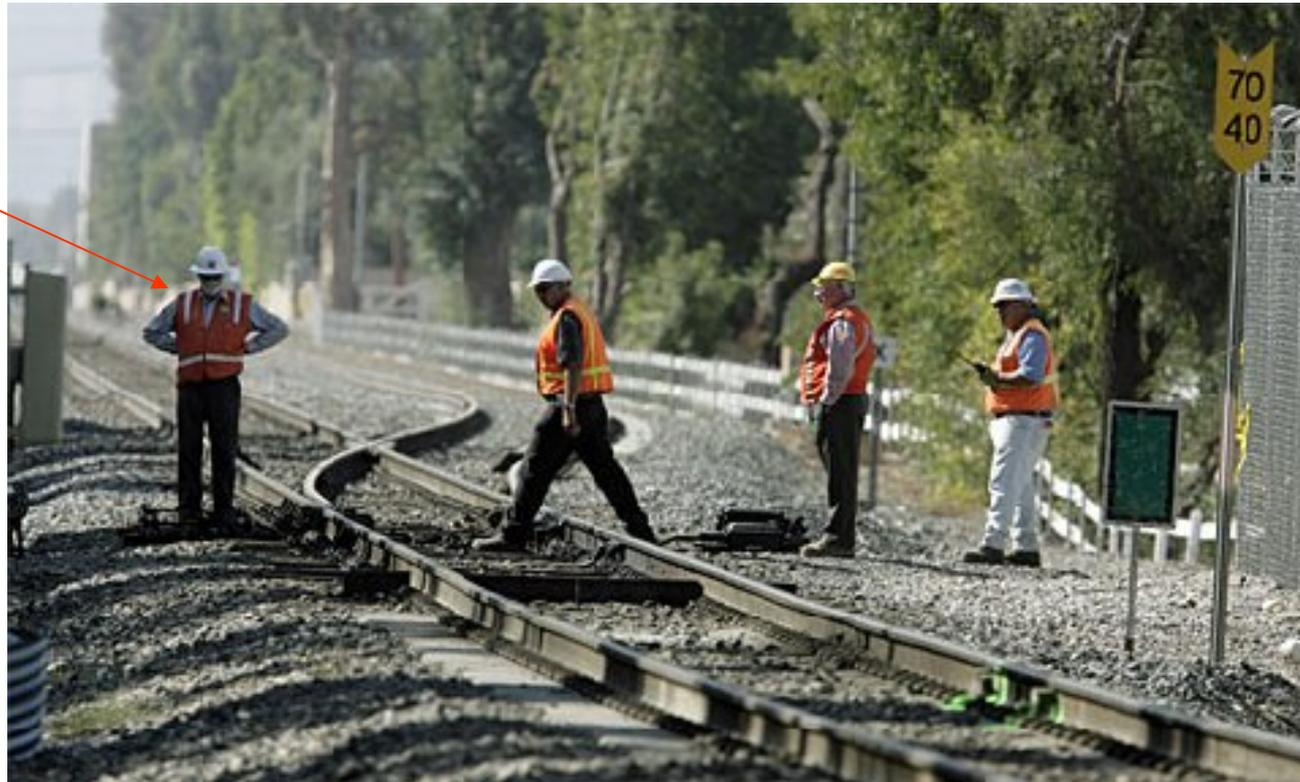
PUC Signal & Train Control Inspector G. Muffley with NTSB Investigators Examining the “Run Through” Switch and downloading the data logger at CP Topanga.

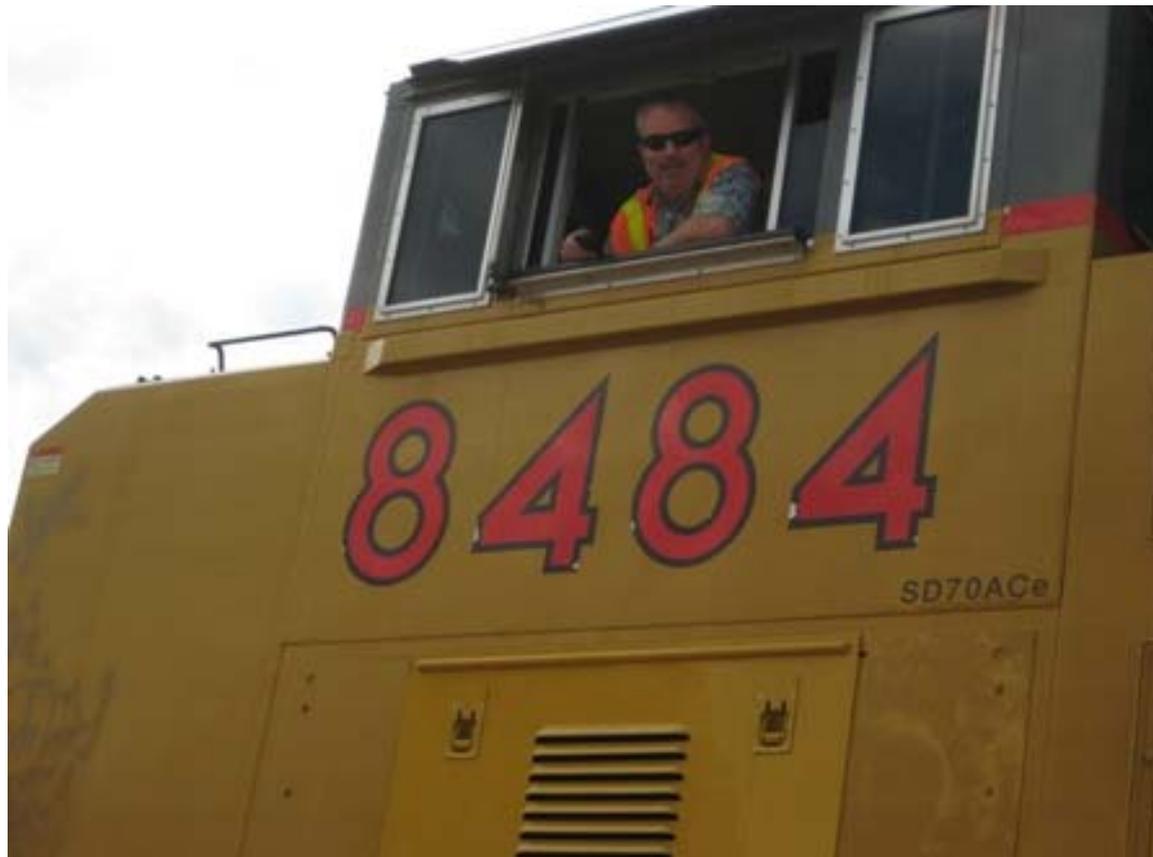
PUC Operating Practices Inspector J. Ellis working with NTSB During the Re-Enactment of the Collision

During this phase of the Re-Enactment Inspectors are looking for sight impairments, how quickly the controls can be manipulated and many other operational issues that the engineer could have done in **FOUR** Seconds prior to impact.
