Brief Overview of the Head-On Collision Between Metrolink Train 111 and a Union Pacific Freight Train September 12, 2008

September 12, 2008 at 4:23 PM
Head-On Collision Between
Metrolink Train 111 and Union Pacific Freight Train

Richard W. Clark, Director
Consumer Protection and Safety Division
California Public Utilities Commission

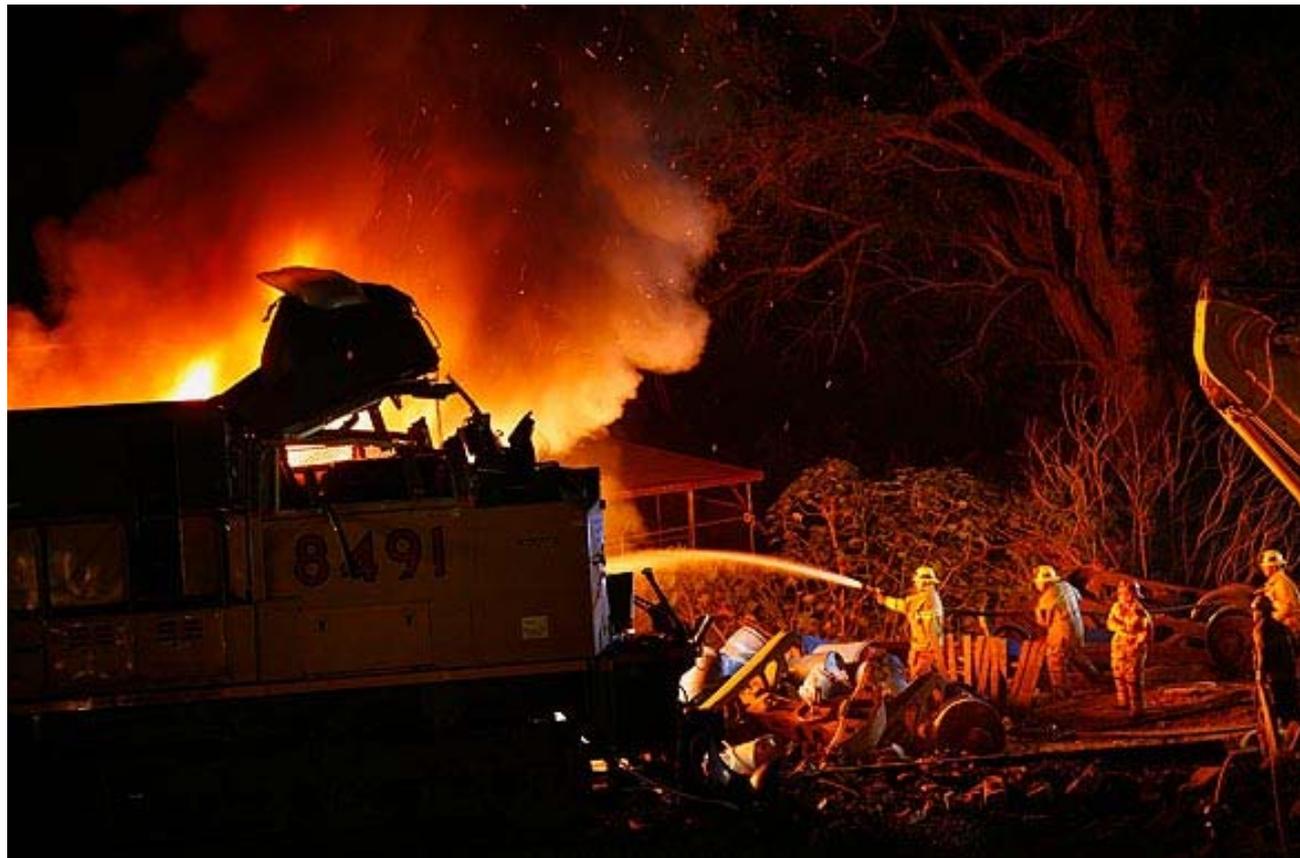
Friday, September 12, 2008
PUC Railroad Safety Inspectors Arrived at the Scene at
Approximately 6 PM to Start the Investigation

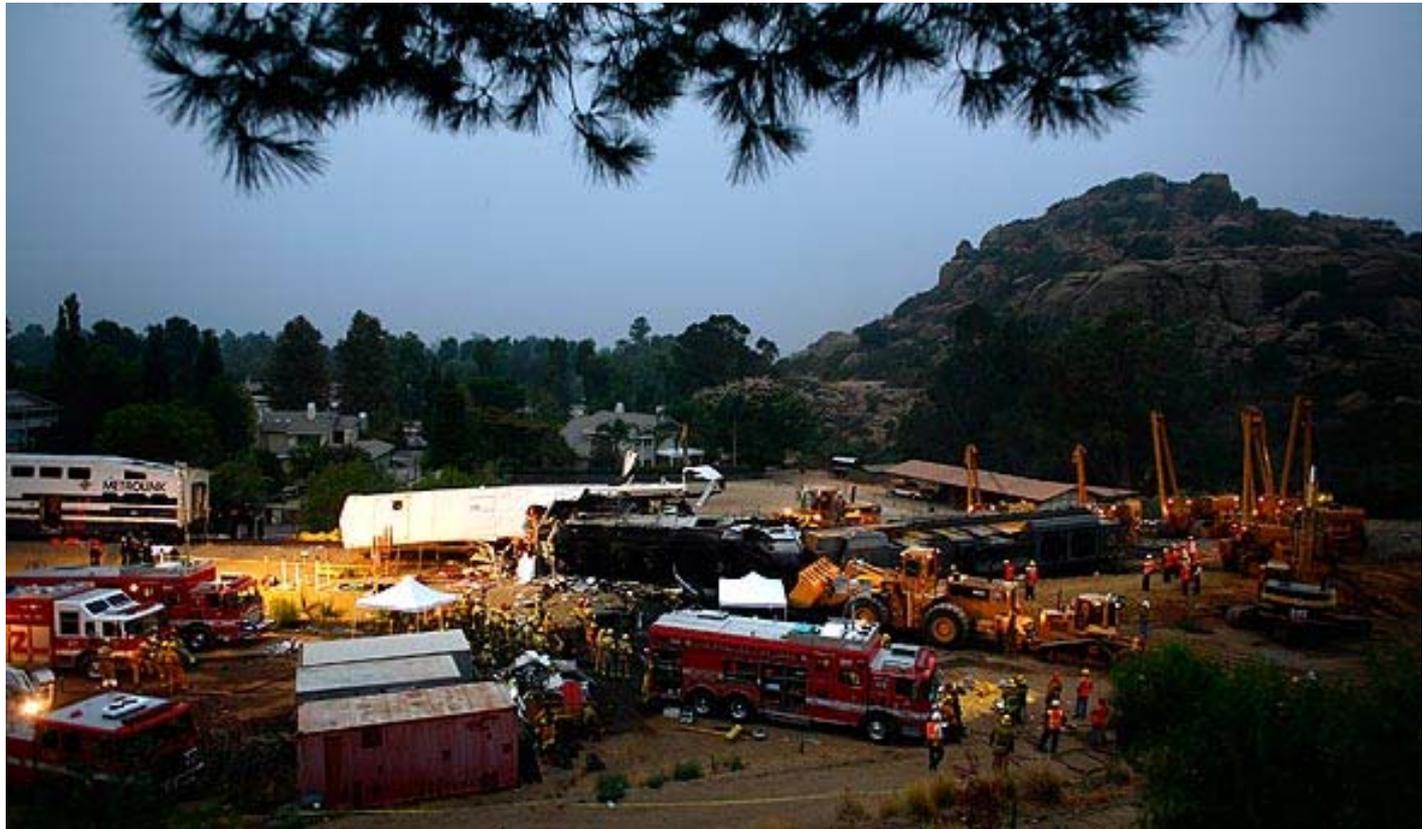
Friday Evening – During the Rescue and Recovery Stage of the Operation

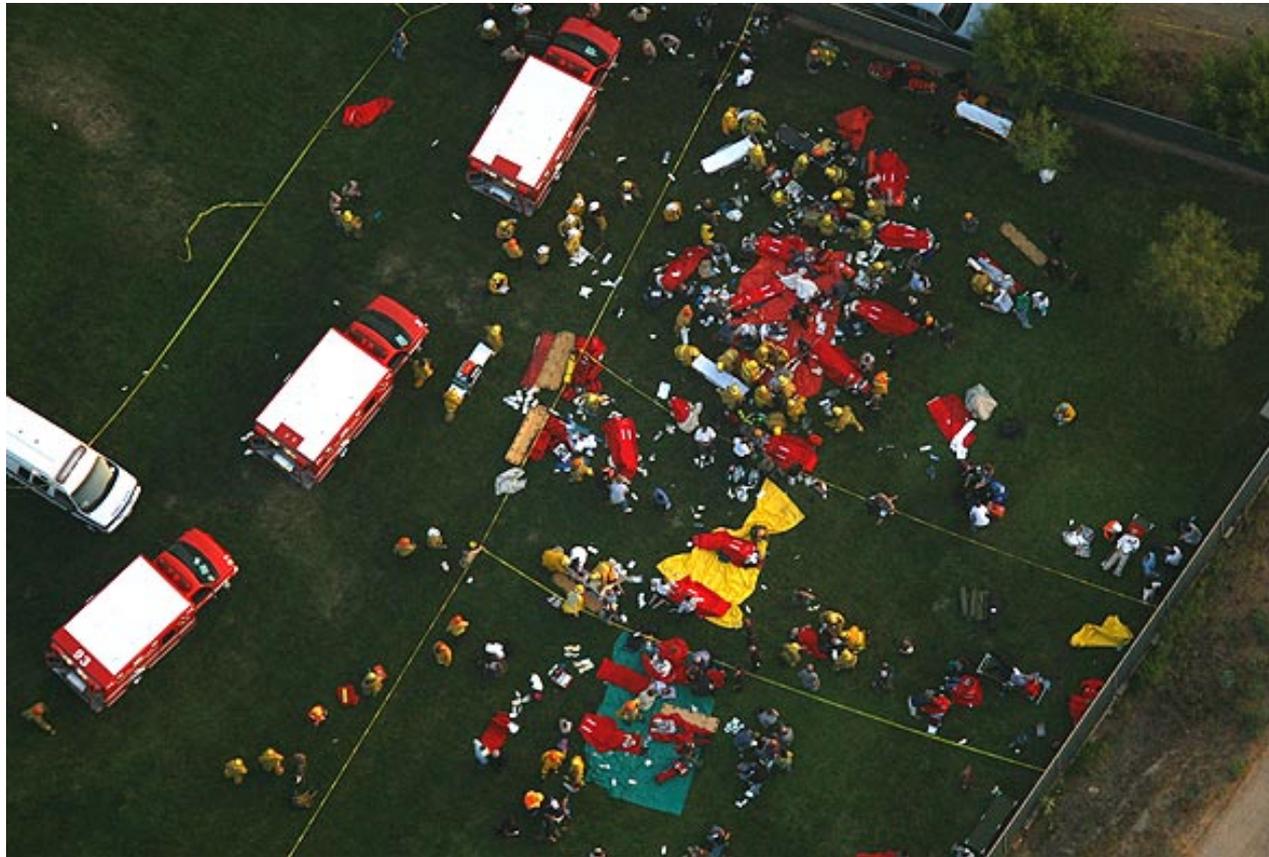
Overhead View of the Triage Area on Friday Evening

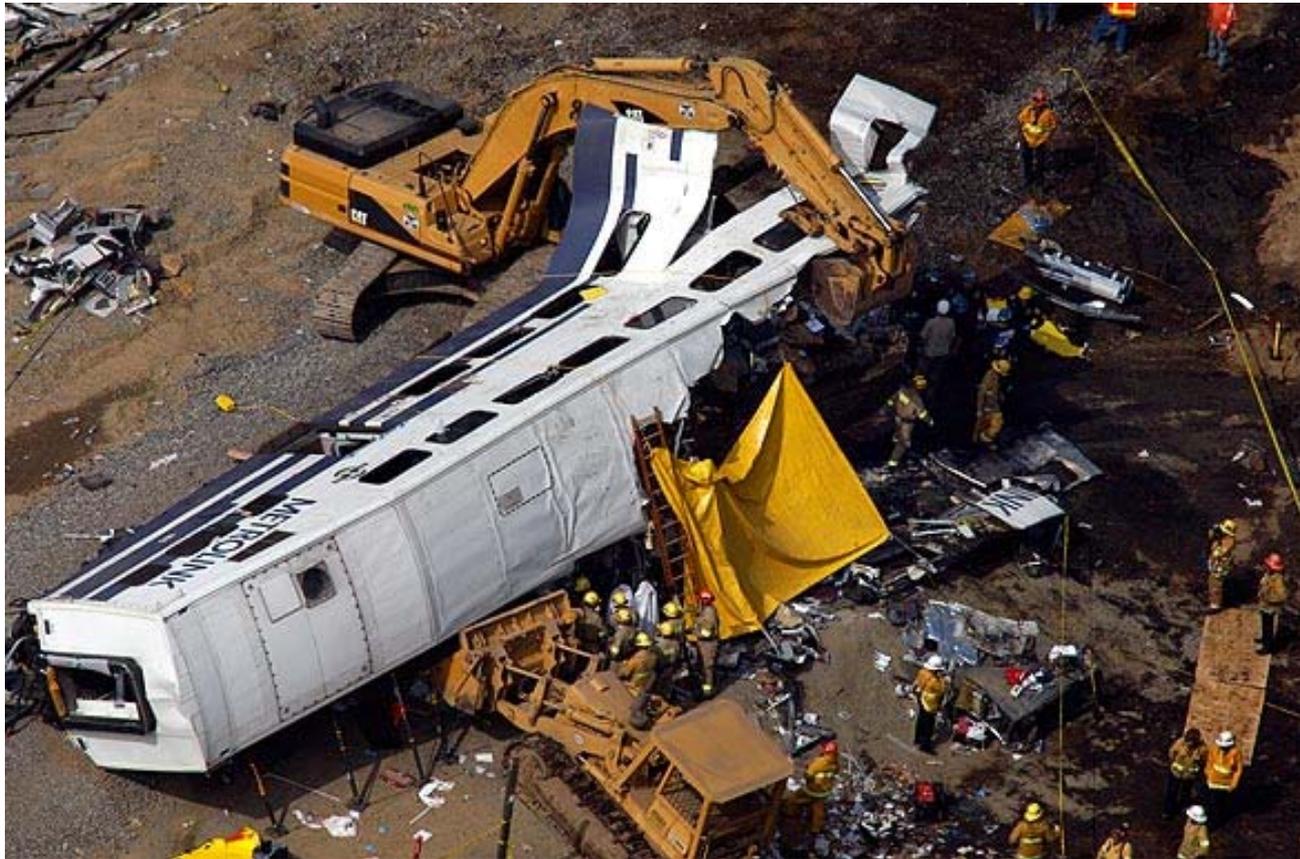
Saturday Morning, September 13, 2008; Rescue and Recovery Still Play a Major Role. Here, Heavy Equipment Lifts and Holds the Passenger Car While Emergency Personnel Remove Bodies.

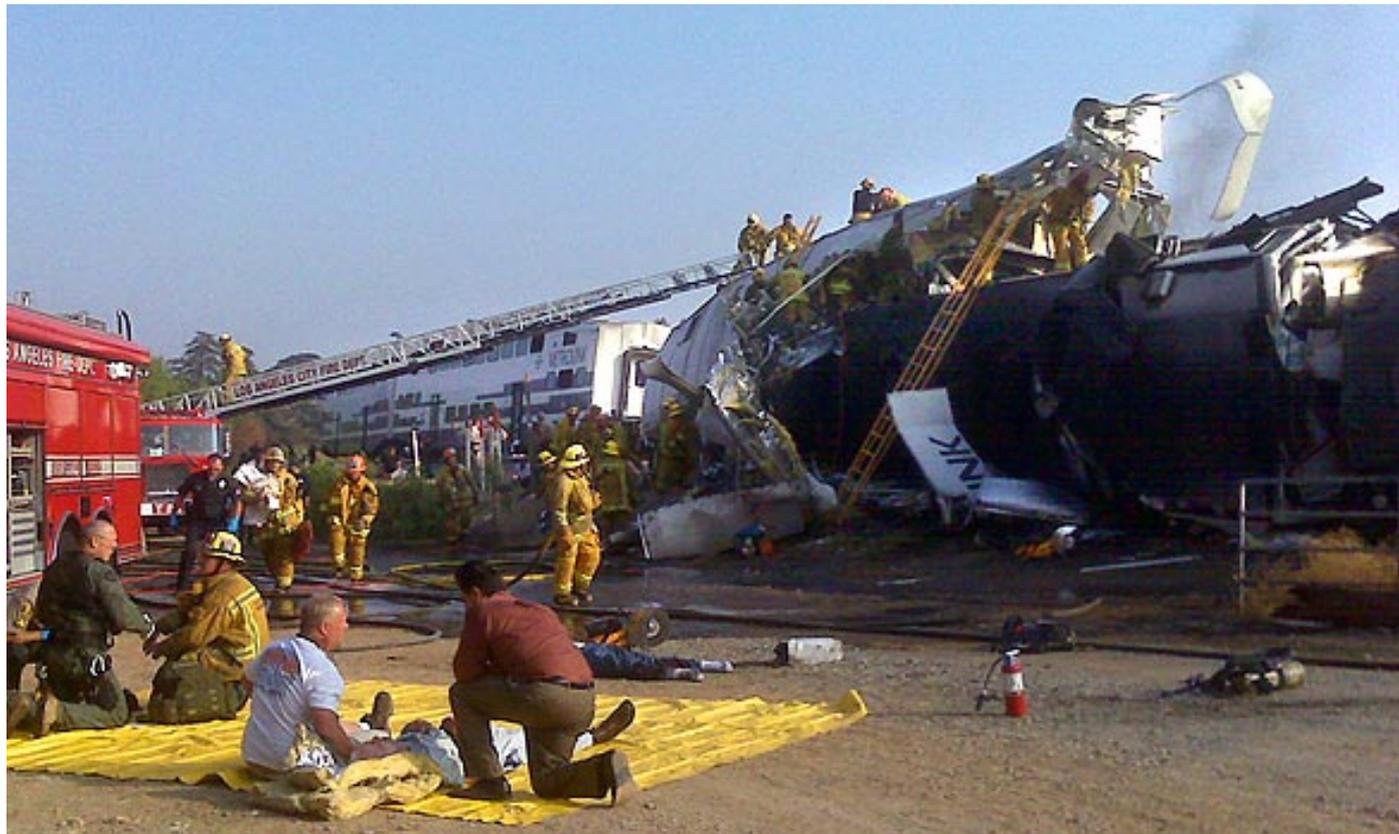
Rescue and Recovery Operations

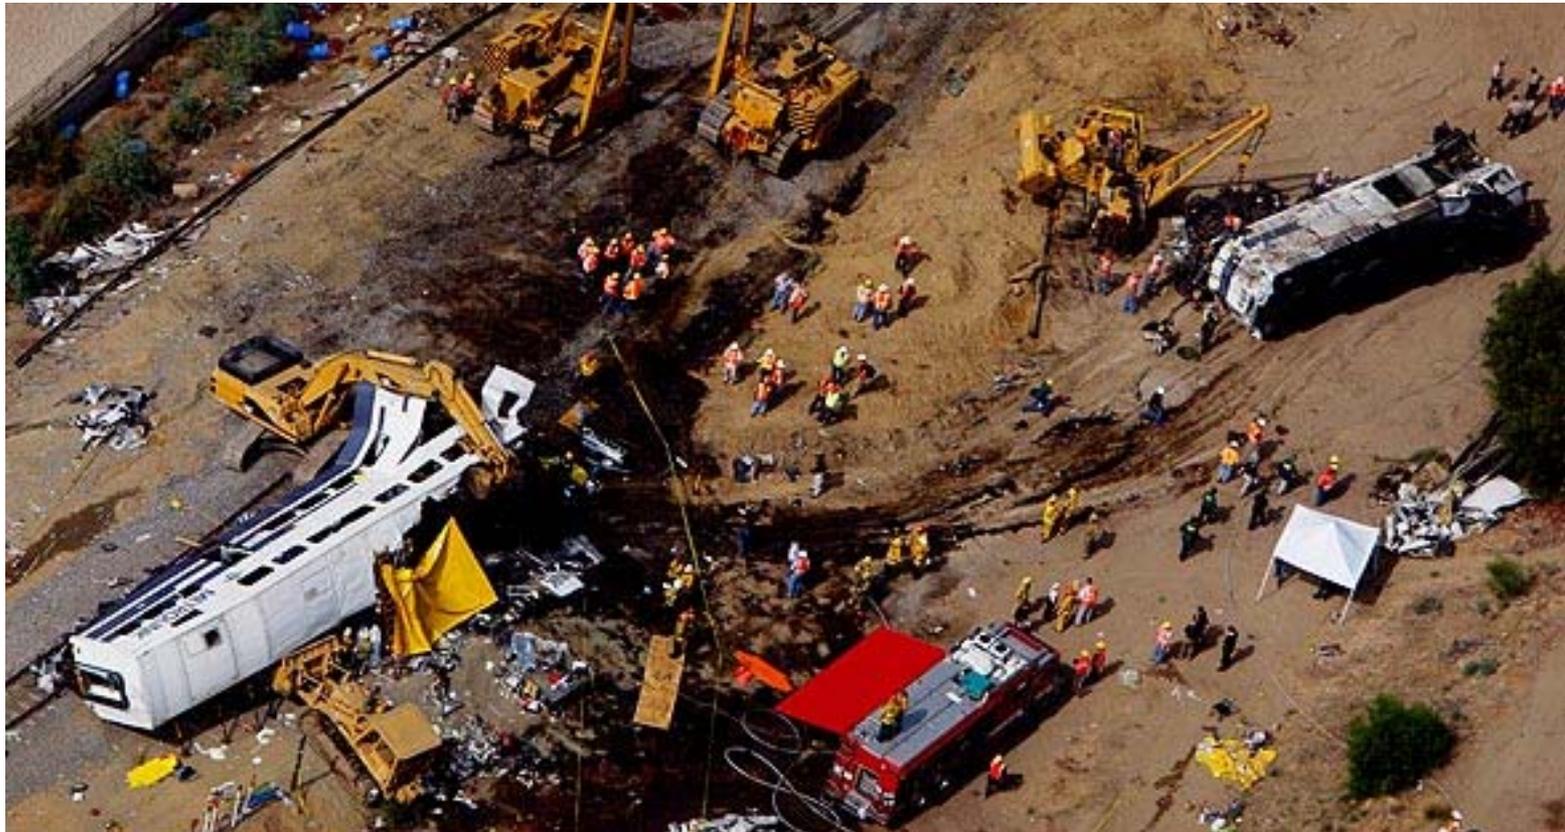
On the Right is the Metrolink Locomotive after the Heavy Duty Equipment Dragged it Away from the Passenger Car Allowing Rescue Workers More Access to Recover Victims. PUC Inspectors Are On Top of the Locomotive.

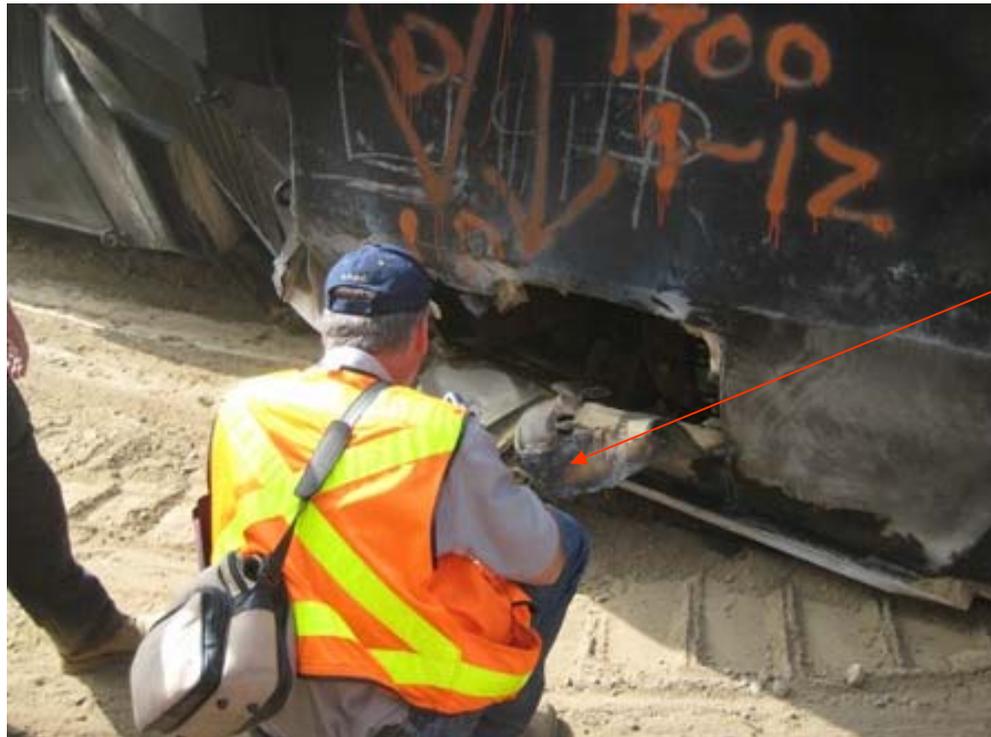
PUC Motive Power & Equipment Inspector Examining the Compartment of the Metrolink Locomotive after the Deceased Engineer was Removed.
